Project Location: Blairsburg, Iowa

Project Overview: Grain bin corrosion.

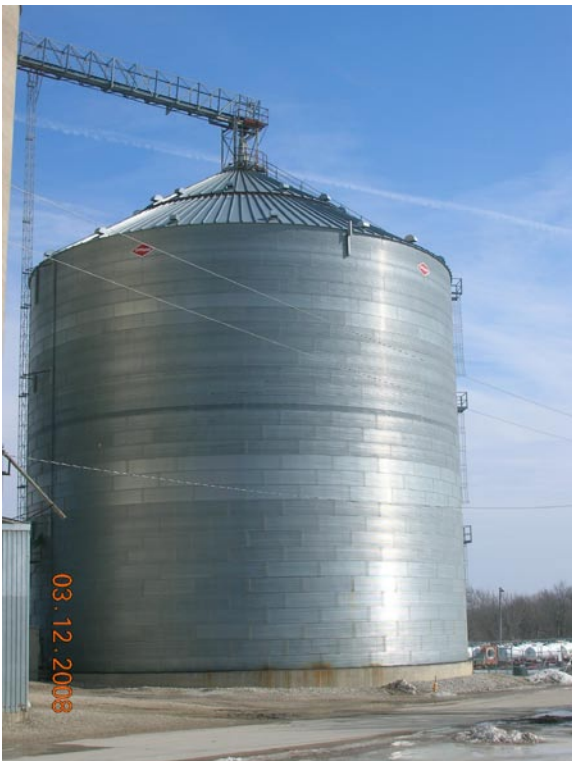
Bin with rusted interior.

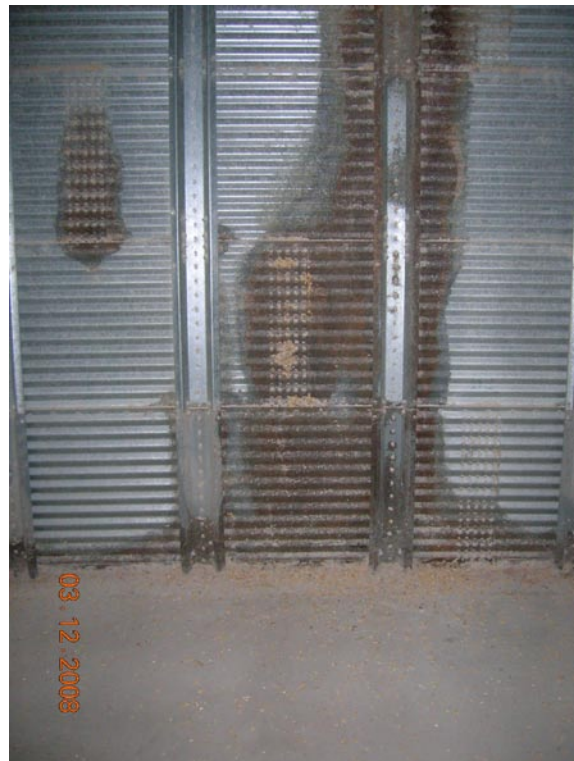
Rust near the base of interior.

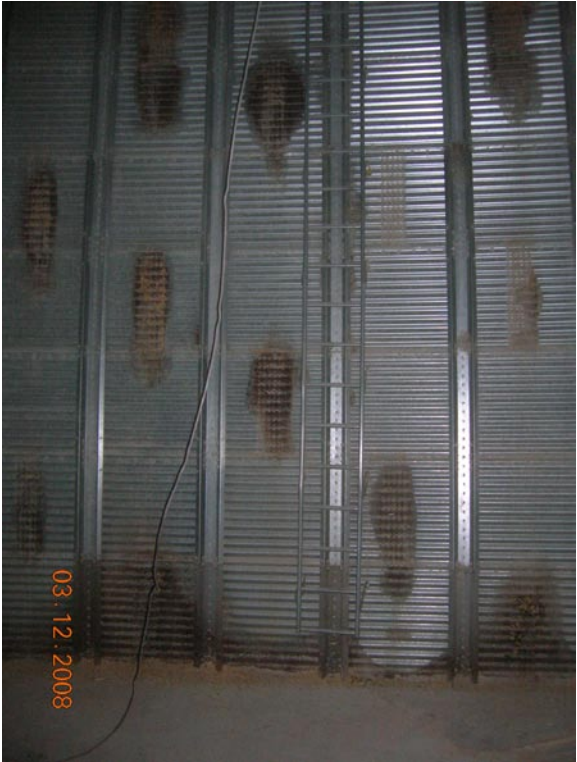
- Interviewed key people regarding standard operation and maintenance of bin, and the construction of the bin. Noted that the contractor was new at bin installation and used a high impact wrench when installing bolts.
- Performed site visit and thoroughly documented the interior and exterior of the bin.
- Observed bin bolts and noted rust was more prevalent in lower two-thirds of bin. Also noted on the exterior that seal washers were missing or severely damaged.
- Concluded that missing and damaged seal washers were allowing water to enter, which led to rust development on the interior. Water seepage started the first year.

Rust at bolt locations.

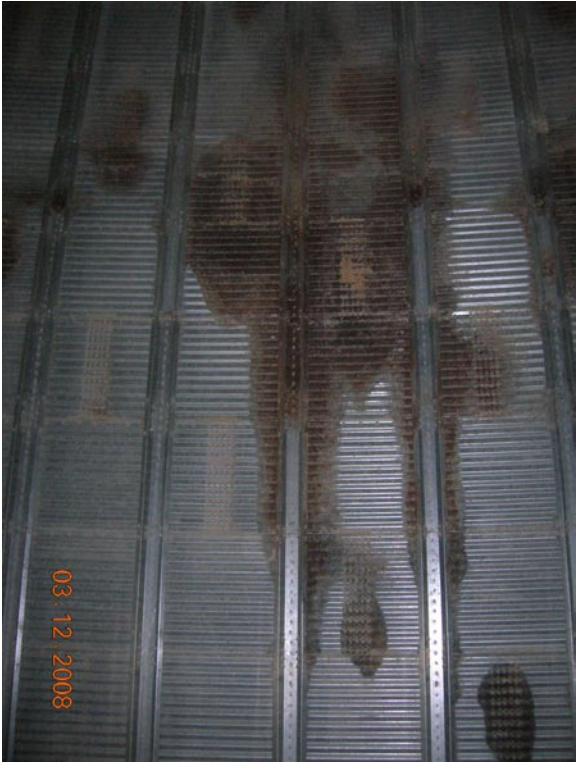
Severe rusting near some stiffeners.

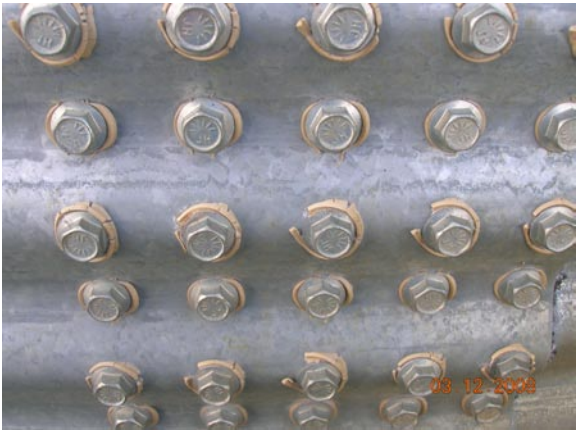
Damaged seal washers at vertical seams

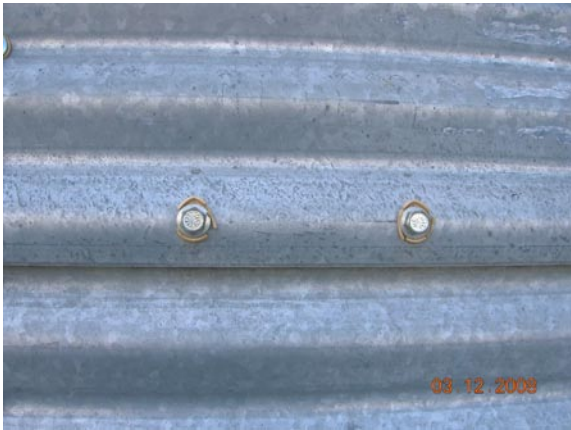
Damaged seal washers at horizontal seams.
