Project Location: Treynor, Iowa

Project Overview: Evaluate grain tower structural failure.

- A 10' x 10' x 120' grain tower that collapsed during a wind storm.
- Determine likely cause of the failure.

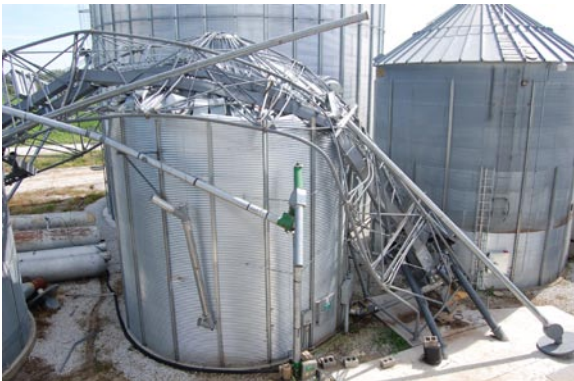
Base of collapsed tower.

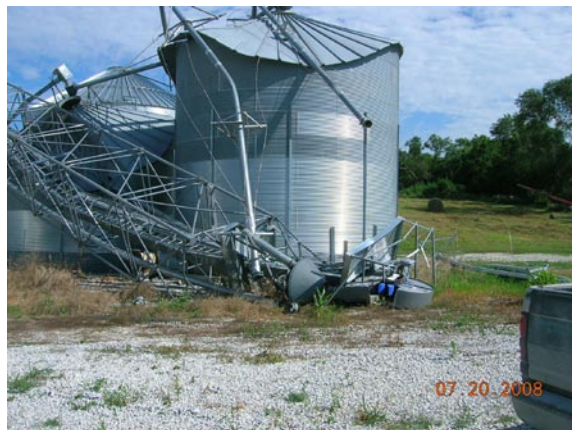
Top of collapsed tower.

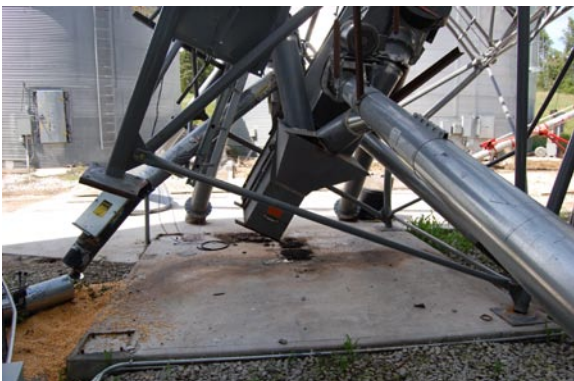
Foundation pad with two legs detached.

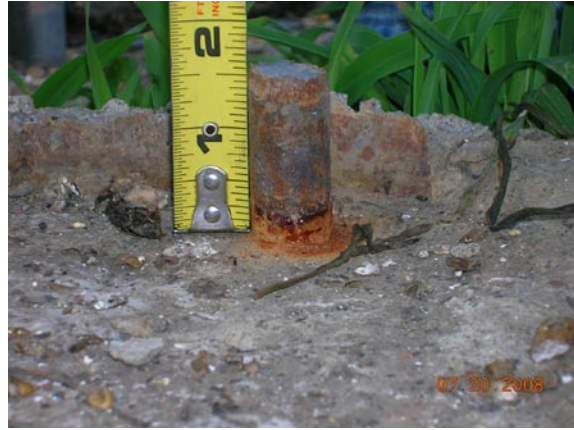
Failed anchor bolt.
