**Project Location:** Treynor, Iowa

**Project Overview:** Evaluate grain tower structural failure.

- A 10' x 10' x 120' grain tower that collapsed during a wind storm.
- Determine likely cause of the failure.

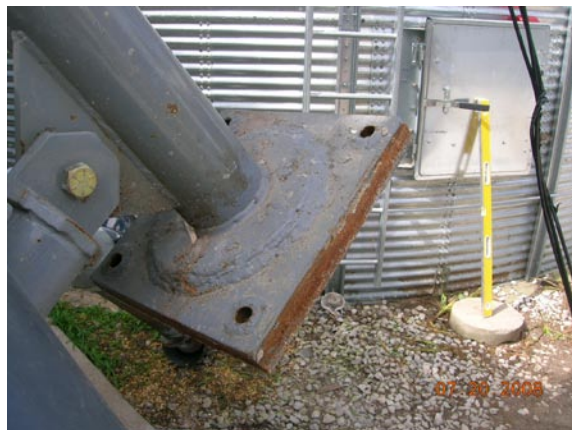
Base plate of tower leg.

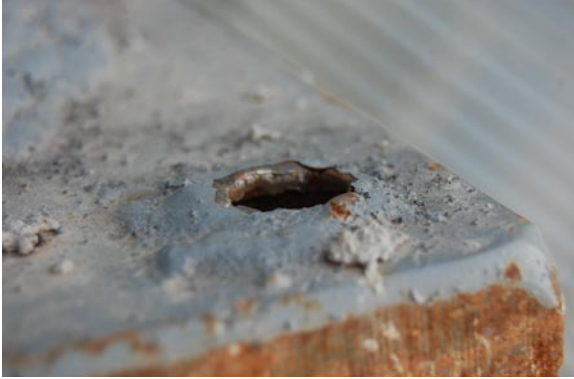
- Performed site visit and thoroughly documented the failure site.
- Researched the manufacturer's installation recommendations. Noted that welding of anchor rods was not according to manufacturer's recommendations.
- Determined minimum design loads based on International Building Code requirements.
- Calculated minimum weld requirements.
- Concluded welds were insufficient, which led to failure during wind storm.
- Submitted final report stating observations, analysis, and conclusions.

Failed anchor bolt weld.
