Project Location: Woolstock, Iowa

Project Overview: Repair Concrete Elevator

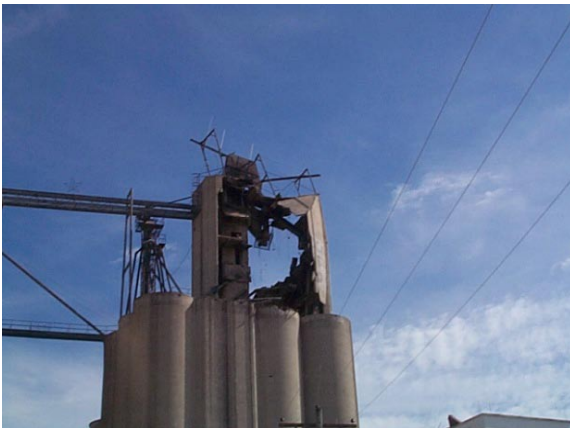
- An explosion destroyed the concrete head house and all the equipment inside the head house, including the manlift and concrete bucket elevator head sections. The explosion also damaged approximately 50% of the concrete bin walls and concrete roof cap, along with some damage to the receiving pit hopper, boot pit transitions, and a couple of reclaim conveyors in the basement.

After the explosion

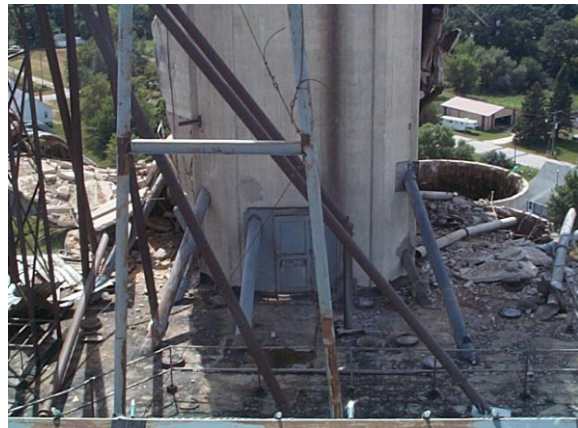
After the explosion

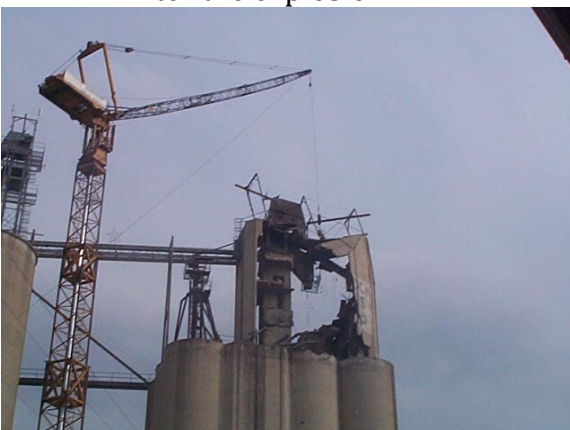
Removing the south concrete wall

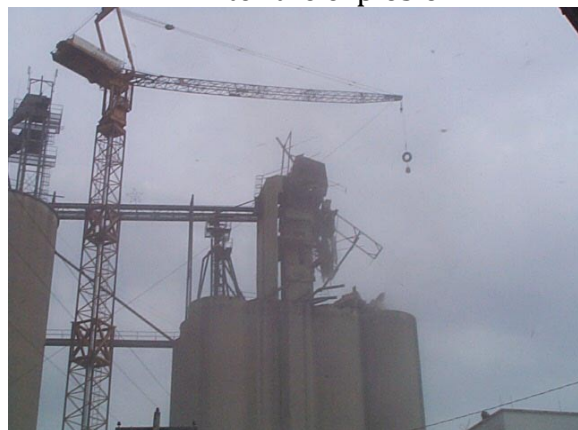
The south wall removed

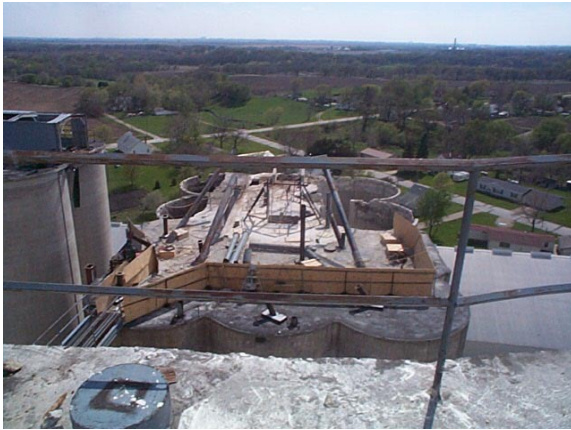
Removing the debris

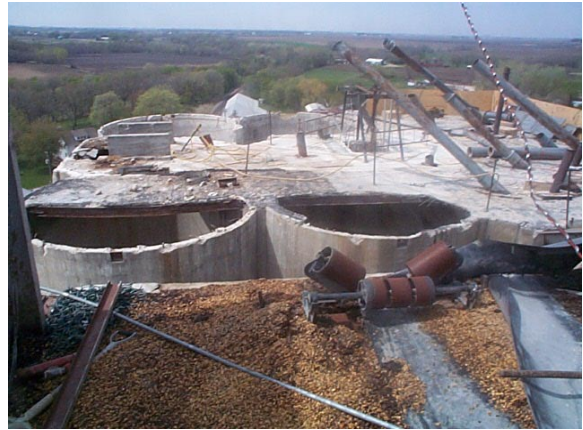
Removing the debris

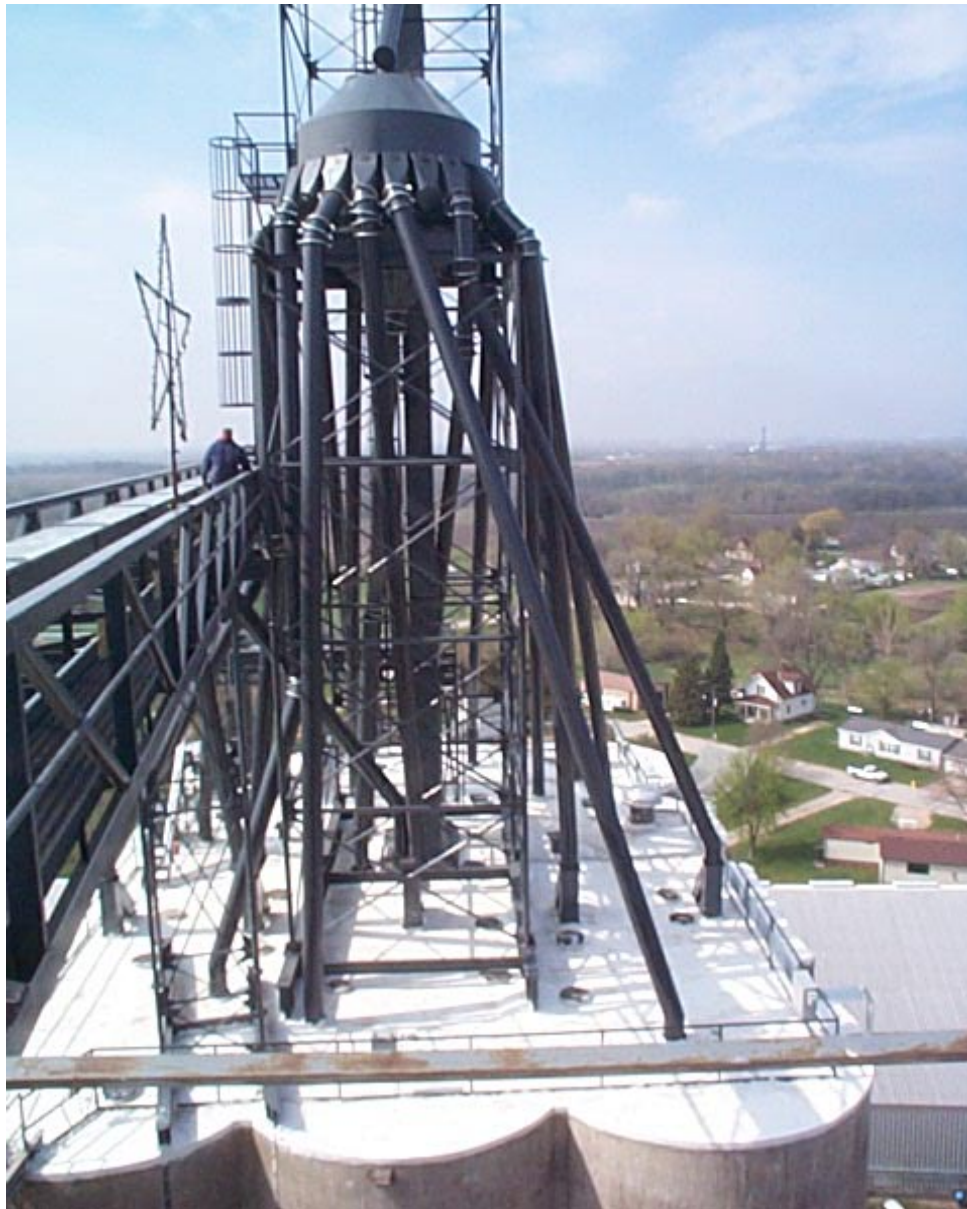
Completed Project.
